Geomorphic Study of Channel Bars in Alaknanda River of Srinagar Valley, Garhwal Himalaya, Uttarakhand

Sapna Semwal and Devi Dutt Chauniyal

*Department of Geography, Hemvati Nandan Bahuguna Garhwal University,
Srinagar (Garhwal), Uttarakhand-246174*

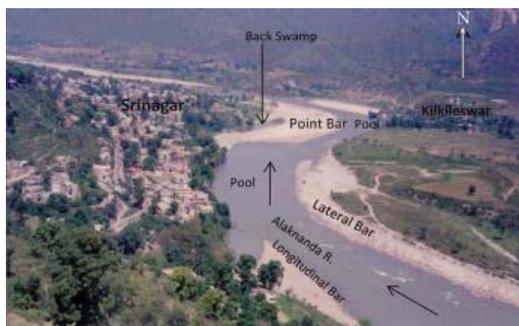
Figure 2. Longitudinal, lateral and point bar along with pool and riffle from Ghasiya Mahadev to Naithana bridge (Field photograph, 2014 facing N).

A classification of channel reach morphology in mountain river valley synthesises stream morphology into the following distinct types of bar surfaces (Fig. 2 and 3).

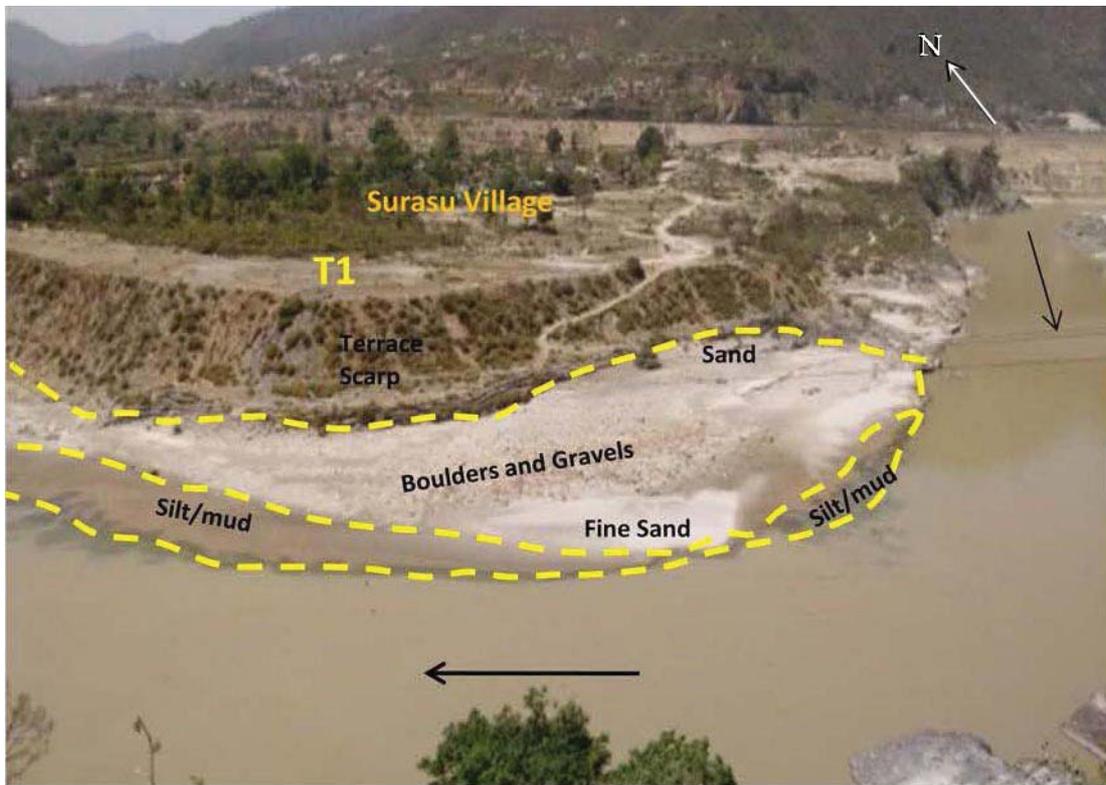
Figure 4. Point bar at Surasu Village (Field photograph, 2013 facing NE)

Some prominent point bars are found in the valley at Surasu (Fig. 4), Srikot (Fig. 7), Chauras suspension bridge and Sriyantra Tapu. At Surasu village and Chauras suspension bridge, the point bar shows stratified deposition of coarse boulders, gavel, fine gravels and sand (Fig.8). The

Fig. 4 shows that the formation of point

bar at a meander bend are due to (i) super elevation of the water surface against the concave bank, (ii) transverse current directed towards the outer bank at the surface and towards the inner bank near the bed results in secondary circulation, (iii) maximum velocity current moves from the near inner bank at the bend entrance to near the outer bank at the bend exit, crossing the channel

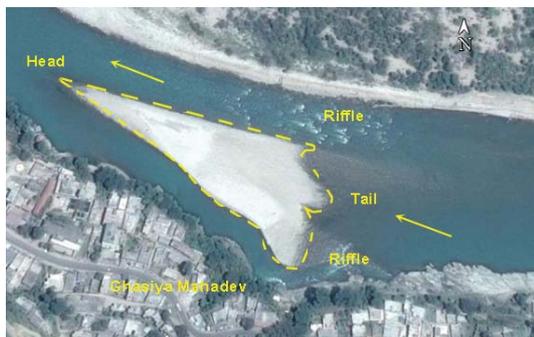
Figure 5. Longitudinal bar near Ghasiya Mahadev (Google Earth Image, 2013)

Longitudinal bars are common in streams with gravel and sandy gravel beds. These bars are developed relatively straight, parallel to the flow direction where the gradient is insufficient to transport the sediment (Fig. 5). The horizontal stratification is well developed and accretion takes place on the margins of the channel (Galloway and Hobday, 1983). Best example of longitudinal bar is observed just downstream of Ghasiya Mahadev (Fig. 5). Three parts of the bar can be recognised as the (i) bar head, (ii) riffle and (iii) bar tail. The head of the bar is sharp, conical shaped which extend towards the flow direction. Due to sudden change in the gradient by riffle formation, the channel is divided into two parts and sediment deposited near the bifurcation, along the channel. In between the two diverging channels a long tail of gravels developed. This bar also bears characteristics of a mid-channel bar. Other examples of longitudinal bar are found at Srikot and just in front of Kilkileswar Naur (Fig. 6).

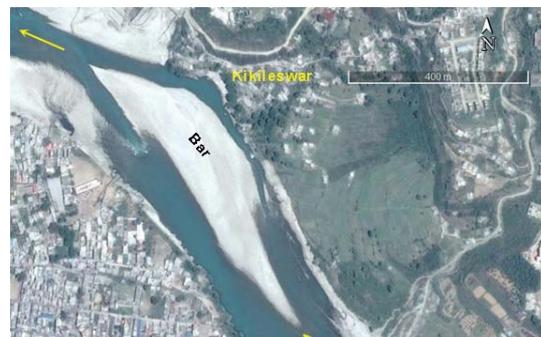
Figure 6. Longitudinal Bar in front of Kilkleswar (Google Earth Image, 2013)

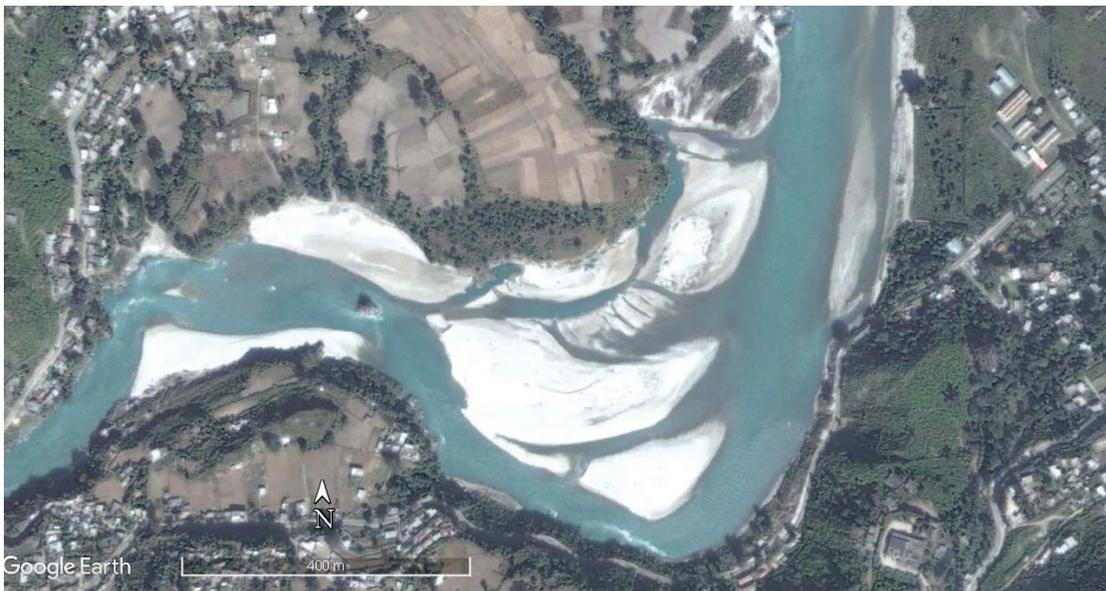
Figure 7. Transverse/ braid bar at Sriyantra Tapu (Source: Google earth image, 2017)

Transverse bars are produced in areas of flow line divergence due to channel widening. In sandy braided streams transverse bars are more common than in the gravelly streams and are extensively developed in the distal part of a braided reach (Reineck and Singh, 1980). Transverse bars commonly occur in braided streams where the gradient is insufficient to remove the sediment. Although the transverse and lateral bars are similar, transverse bars tend to migrate downstream while lateral bar tend to accrete laterally into the channel. Jackson (1976) describes transverse bars from the meandering Wabash river of USA. Martini (1977) discussed that in tight bends of a stream helicoidal flows are important in shaping transverse bars. The prominent example of transverse bar in the study area is at Sriyantra Tapu (Fig. 7). There are number of transverse bars which are attached to the channel margin and show some similarity to point bars as they develop by lateral migration. Due to insufficient gradient to remove high sediments load, there is loss of channel competency and braiding starts at this point. Fig. 7 shows that the flow of water has formed a complex

pool at the outer bend of the meander and in the inner part of the meander there is a wide expanse of deposited material. As a result, the main channel has divided into a number of distributaries towards the inner margin to form a transverse bar.

A braided channel pattern is usually characterised by a wide and shallow channel divided by many unstable mid-channel bars. Braid bars or channel bars are found in the Sriyantra Tapu meander bend in the Alaknanda River (Fig. 7). These bars start to form when the discharge is low and the river is forced to form multiple channels to follow the route of less resistance. During times of extremely high flow, the bars may become covered by water; only to re-surface when the water recedes. Their formation starts when the river begins to erode the outer edges of the bar. The water level decreases even more as the river laterally erodes the less cohesive bank material resulting in a widening of the river and a further exposure of the braid bar. As the discharge increases, material may

Massive amount of sediment creates multiple stream channels within the flood plain. Anastomising river channels also create mid-channel bars; however they are typically vegetated bars, making them more permanent than the bars found in a braided channel which record high rates of channel shifting because of the deposition of large amounts of non-cohesive sediment, lack of vegetation and high stream power found in braided river channels (Schuurman *et al.*, 2017). The gradient being insufficient to remove the sediment, lateral bars commonly change over to braided bars. Although the transverse and lateral bars are similar, transverse bars tend to migrate downstream while lateral bar tend to accrete laterally into the channel (Fig. 7).

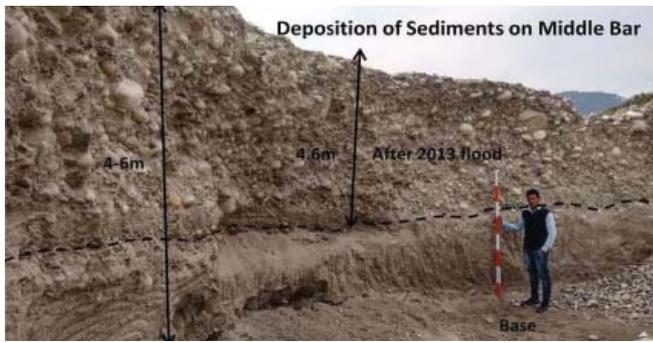
Figure 9. Thickness of the sediment on middle bar at Srikot

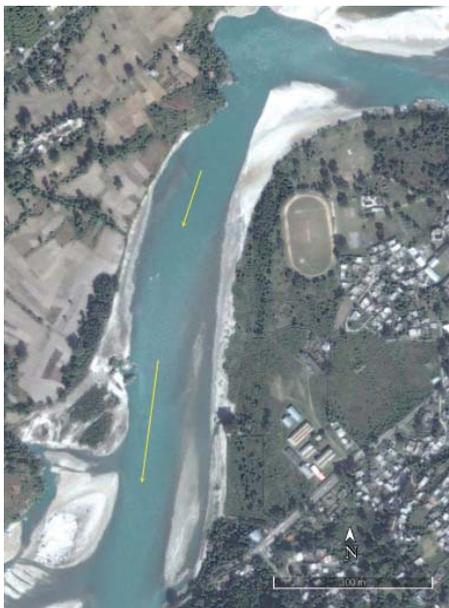
Figure 11. Lateral Bar along Alaknanda river at SSB Srinagar

Lateral bars are elongated features attached to banks along relatively straight channels which commonly alternate from bank to bank. These are sometimes the extension of point bars. Lateral bars are found along the Alaknanda river at Naithana bridge, between Nathan and Ranihat villages (Fig. 11 and 12).

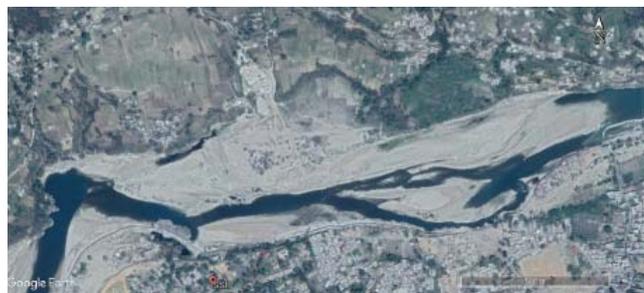
Figure 12. Lateral bar between Naithana and Ranihat village

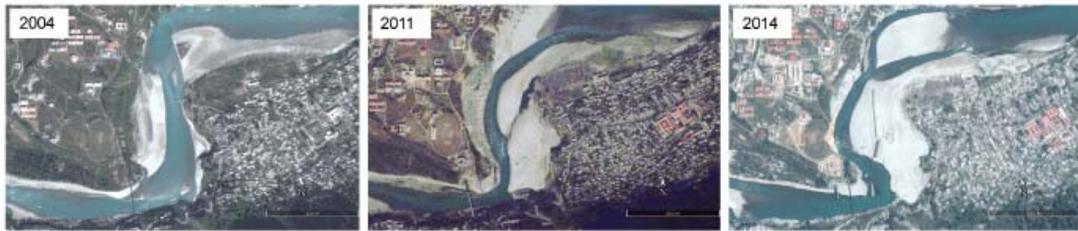
Figure 15. Changing pattern of bars at Srikot in 2004, 2011 and 2014

The most significant change in river morphology took place in the inner bank of the channel at Srikot-Chauras meander bend of the studied reach. Fig. 15 (2004) is showing the Google earth image of the river course in 2004 at Srikot meander bend. The river was forming a pool at the head of the meander and followed a straight course from north to south. The toe of the point bar at the slip-of-slope was cut by the river. In the western bank there was a sizable lateral bar. After 2010 flood, the channel morphology changed completely. Fig. 15 (2011) shows that the river formed a lateral bar in the same

place where the pool existed.

In Fig. 15 (2011) the river was flowing between the lateral bar and point bar from northeast to southwest direction. That was the effective flow path of the channel which changed significantly in 2013 flood. Before 2013 no mid-channel bar or longitudinal bar existed in the channel, but after 2013 major flood, the channel course shifted towards the outer bend of the meander and undercut the Chauras terrace scarp. It is calculated that the channel length increased about 220 m than the length in the previous year. Here the channel divided into two branches (Fig.16, 2014). After sudden reduction in velocity with decreasing gradient, sediments were deposited in the middle of the channel. As a result the channel diverted into two branches, though the outer branch is more active in comparison to the inner branch. In between these two branches there is a crescent-shaped

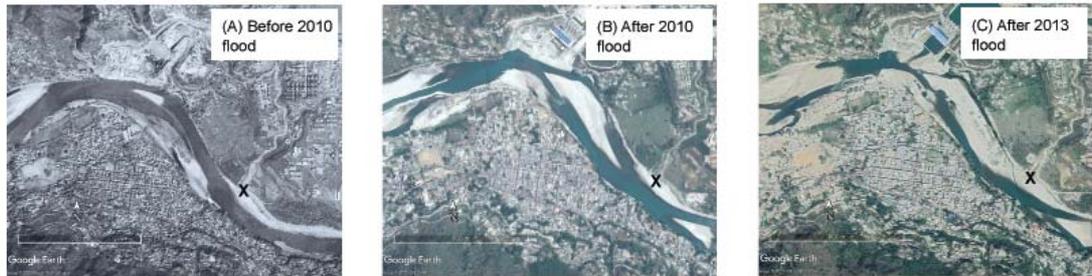
Figure 17. The changing pattern of bar and channel at Kilkileswar locality

The second prominent example of changes in bar formation was observed from Ganga Darshan to Naithana Bridge near Kilkileswar. Fig. 17 A shows that before 2013 flood, the main river channel flew just besides the Kilkileswar temple and formed a point bar feature just opposite the temple. The main channel flowed right of the point bar. After 2010 flood, the channel divided into two branches and in between the two branches a longitudinal bar was formed (Fig. 17 B). The flow gradually increased in the southern branch and there was reduction of flow in the northern branch. After 2013 flood the longitudinal bar converted into a lateral bar (Fig. 17 C).
